EARTHQUAKE RESISTANCE BUILDINGS **AND CONSTRUCTION PRACTICES**

MASTERS OF ARCHITECTURE

SCHOOL OF ARCHITECTURE AND PLANNING
BBD University, Lucknow

3.1 CASE STUDY: (2015 Nepal earthquake)

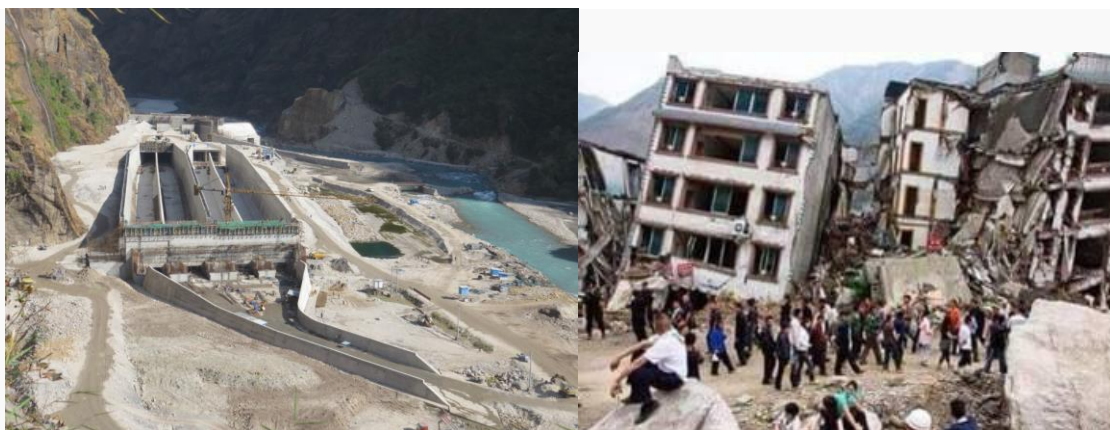
Upper Tamakoshi HEP under construction, it was damaged in the earthquake

Workers stuck at Upper Tamakoshi HEP In a news report that appeared eight days after the earthquake, Ganesh Neupane, chief of the environment division of the Upper Tamakoshi Hydropower Company Limited[13], said some 200 Chinese technicians and engineers as well as 70 Nepalese workers are stranded in the powerhouse station at the hydropower project site after a massive landslide caused by the earthquake blocked the 11-kilometer-long Lamabagar-Gongar stretch of the road connecting the region. The 456 MW Project of Nepal Electricity Authority is located at Lamabagar VDC, Dolakha District, Janakpur Zone, Central Development Region. The workers are stuck but safe at the Upper Tamakoshi hydropower project in Lamabagar Area in Dolakha district, where reports suggest that more than 90 per cent of houses in rural areas have been destroyed. The stranded workers are from China's Sinohydro Corporation Limited, the contractor of civil construction work for the Upper Tamakoshi Hydropower Company Limited in charge of the project.

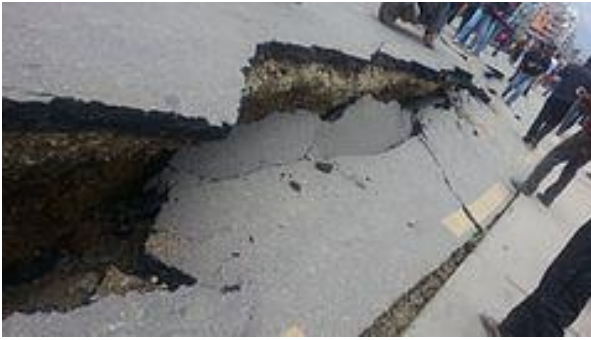
Road damage in Nepal

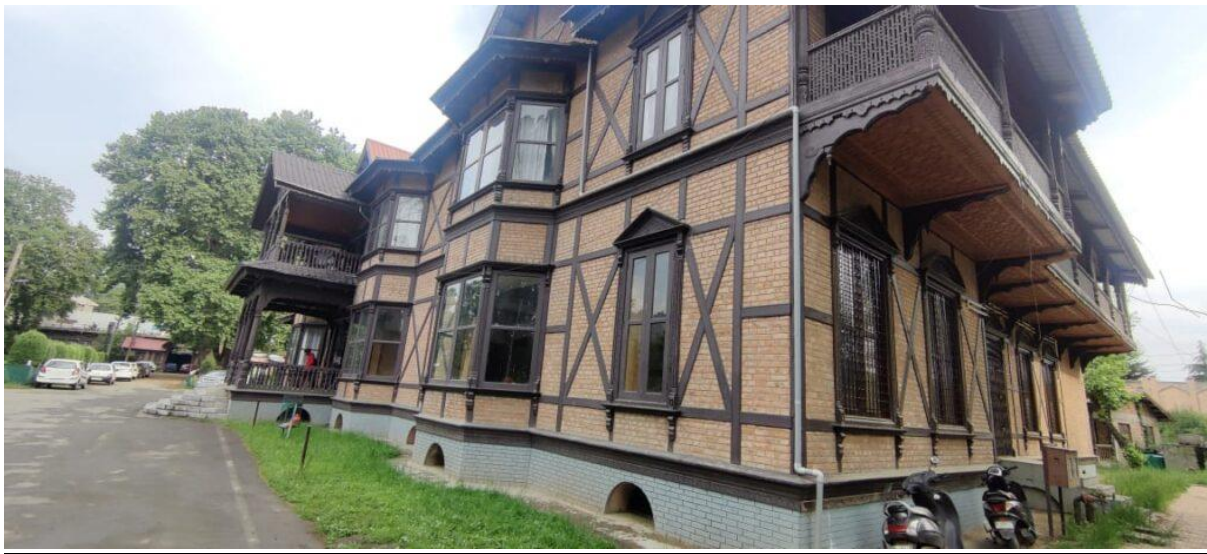
• Dhajji-Diwari Buildings of Kashmir

The Dhajji-Diwari buildings were the one of survive when part of the palace and other massive old buildings collapsed in the Srinagar quake of 1885. The most significant aspect of the Dhajji-Diwari buildings is the combination of the building materials used. These materials are locally available and have been used for generations. The basic elements in these buildings are the load bearing masonry piers and infill walls.

There are wooden tie-bands at each floor level. The foundation consists of rubble masonry with lime mortar whereas, mud mortar is used for the rest of the structure.

The infill materials are usually abode bricks bonded with mud mortar. The wooden bands tie the walls of the structure with the floors and also impart ductility to a structure that is otherwise brittle. The unreinforced masonry walls have stiffness but not strength. In the absence of strength, flexibility is essential for quake resistance. Here, the desired flexibility is provided by the combination of wood and unreinforced masonry laid in a wear mortar. The wooden beams tie the whole house together and ensure that the entire building sway together as one unit in an earthquake

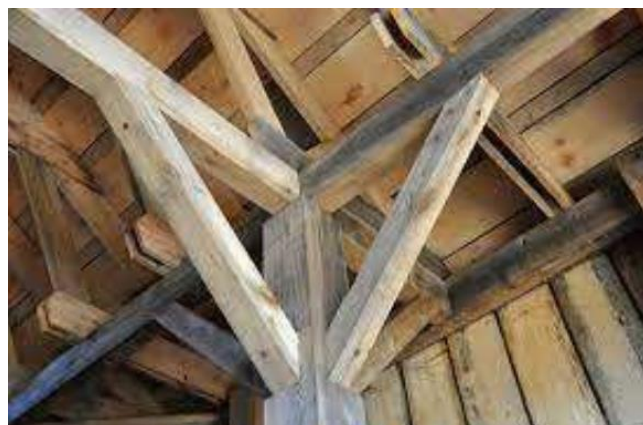
• Kat-Ki- Kunni Buildings of Kulu Valley

Similar to the Pherols and the Dhajji-Diwari buildings, the Kat-KiKunni or timber cornered buildings suffered minimal damage in the epicentral tract of Kulu Valley during the 1905 Kangra earthquake. This structure is almost identical to the Pherols of Uttarkashi. It combines the weight, solidity and coolness of a stone building with the flexibility and earthquake-resisting qualities of a wooden one.

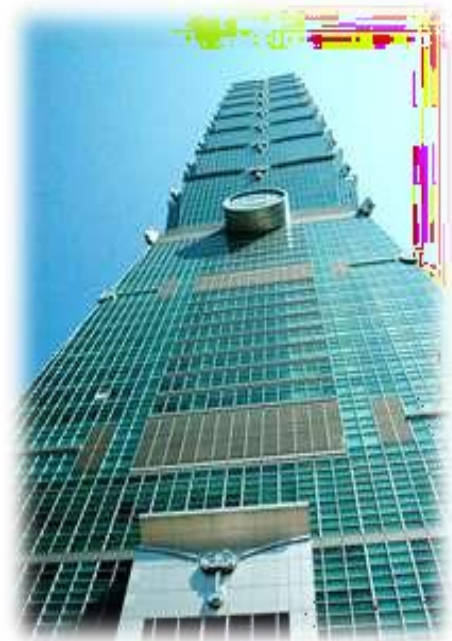
TAIPEI 101

- ARCHITECT – C.Y.LEE & PARTNERS
- ADDRESS – TAIPEI CITY ,TAIWAN.
- CONST. MATERIAL – STEEL, IN SITU CONCRETE AND GLASS
- YEAR STARTED – JUNE 1998 (MALL ALREADY OPEN)
- DATE COMPLETED – DEC 2004
- TOTAL HEIGHT – 508M
- NO. OF FLOORS – 101
- PLAN AREA – 50M X 50M
- COST – \$ 700 MILLION
- BUILDING USE – OFFICE COMPLEX + MALL

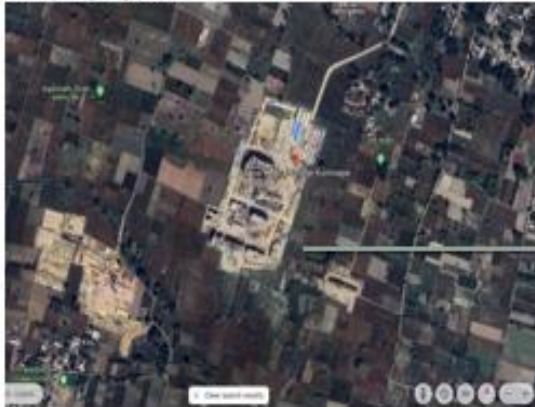
The site is situated in commercial and agricultural zone as there are existing institutional buildings and plotings for future projects.
