“Causes, Prevention & Repair of Cracks”

BACHELOR OF TECHNOLOGY

CIVIL ENGINEERING

BBD UNIVERSITY
FAIZABAD ROAD, LUCKNOW
[2020-21]

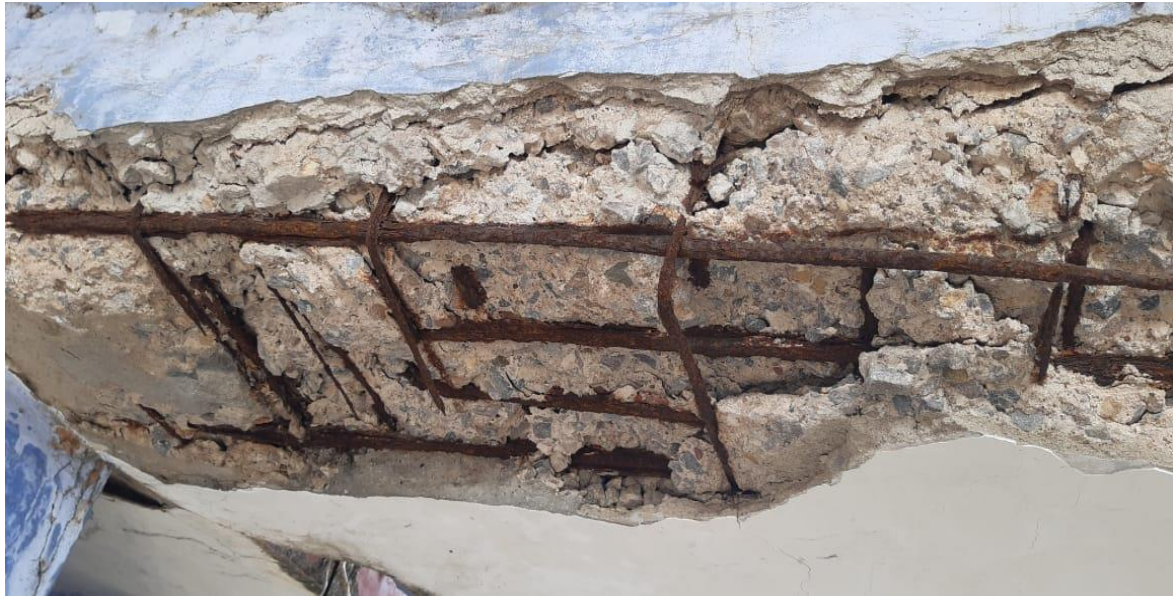
Fig 3.2

The reinforcement steel is well protected by a properly designed and constructed concrete, this physical barrier of concrete has low permeability and high density. The cover of concrete around the reinforcement steel provides a chemical protection and this steel is safe and will not undergo corrosion as long as concrete around it is not pervious and does not allow chemicals to penetrate within the area. When the concrete around the steel is alkaline and have high pH value the corrosion of steel will not occur when a structure is well designed and structured excellent protection to reinforcement steel is provided by concrete. In cases, where the structure is not properly designed there is no excellent protection provided by the concrete to the reinforcing steel. This, in the long run has caused severe damage to the concrete structures resulting in the loss of bond, durability, stiffness and ultimately loss of strength in the whole structure takes place.

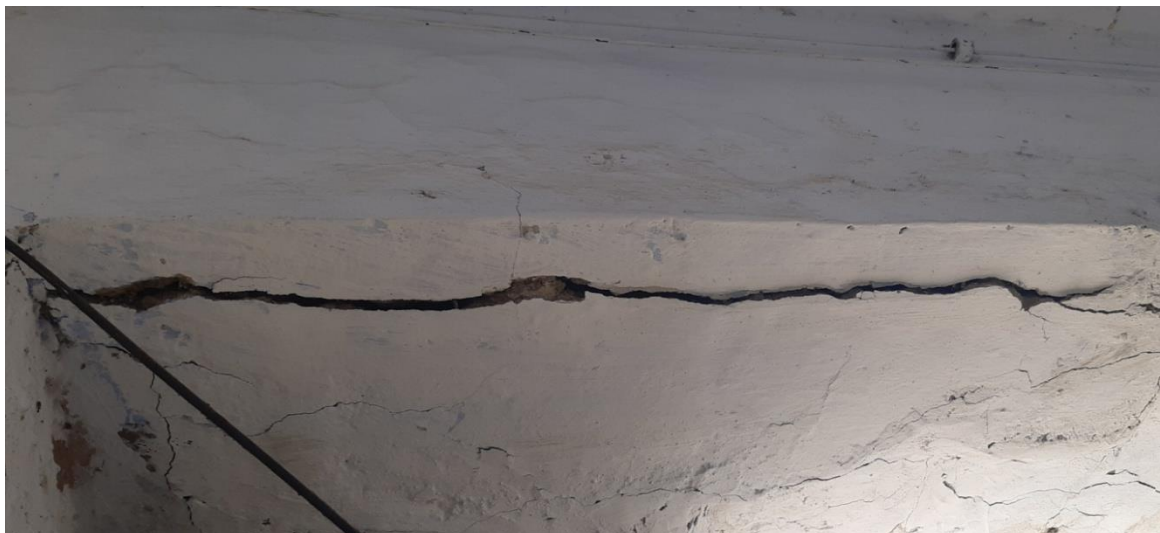
Fig 3.3

Extensions and Bays

- Extensions and bays can ‘rotate away’ due to subsidence
- Quite often the foundations are a different from the main structure
- Tapering cracks appear at or near the junction of the projection

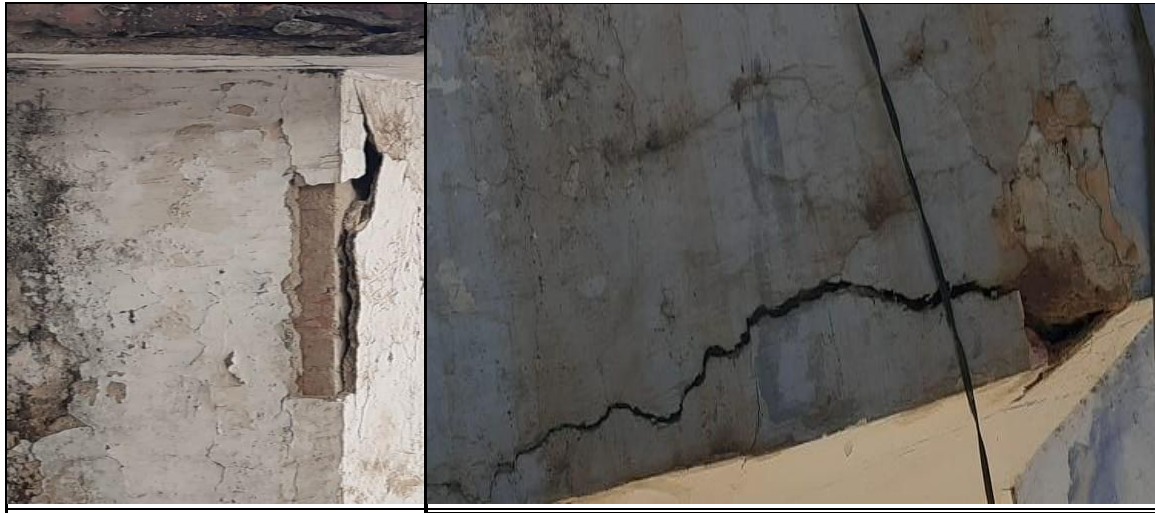
Fig 3.4

3.11) Inadequate Foundations:

- Generally, only a problem found on older properties and may affect all or only part of the structure (problems with garages, porches and bay windows and conservatories are particularly common).
- Strip foundations too narrow to adequately support imposed loads resulting in differential movement.
- Shallow foundations built within the shrinkable clay zone or on loose or poor made ground.

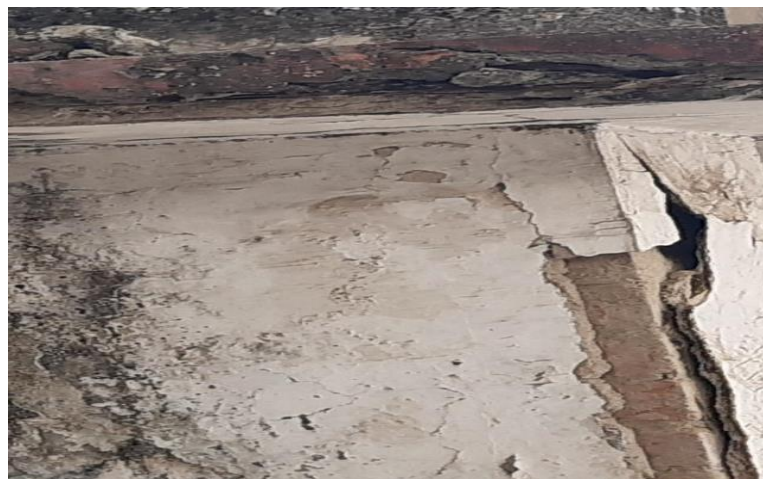
Fig 3.5

a) If the tree is the same age or younger than the building there is no risk of heave.

b) If trees are older than an adjacent building i.e. the building was constructed on a desiccated soil there is a possible risk of heave.

Opposite to Subsidence with tapered stepped diagonal cracking wider at the bottom

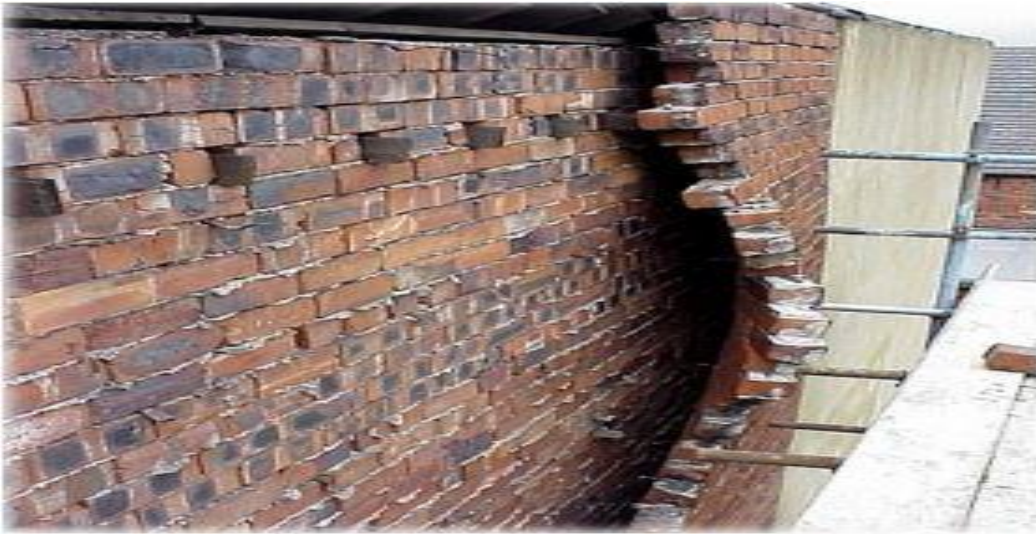
No Wall ties causing bowing and 'peeling'

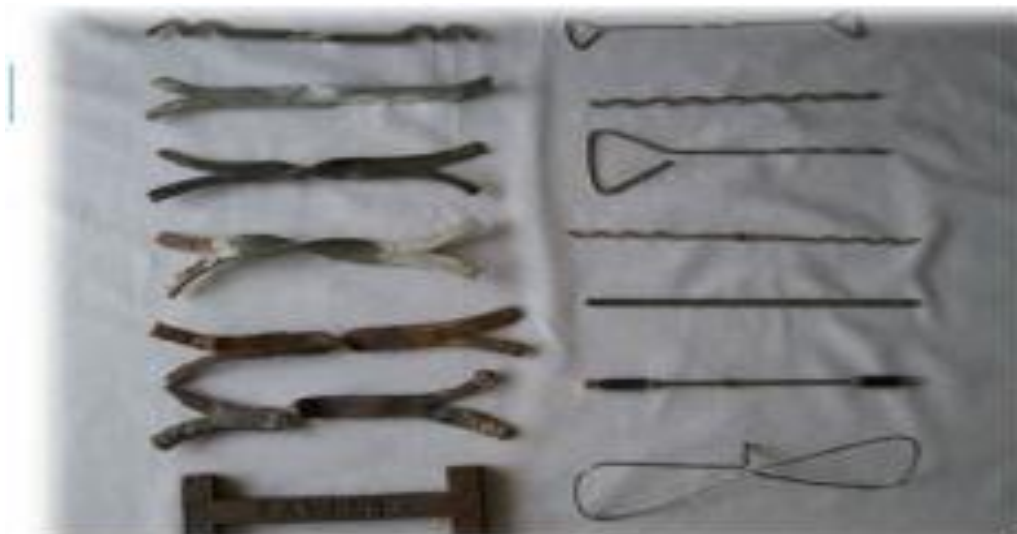
Wall Ties

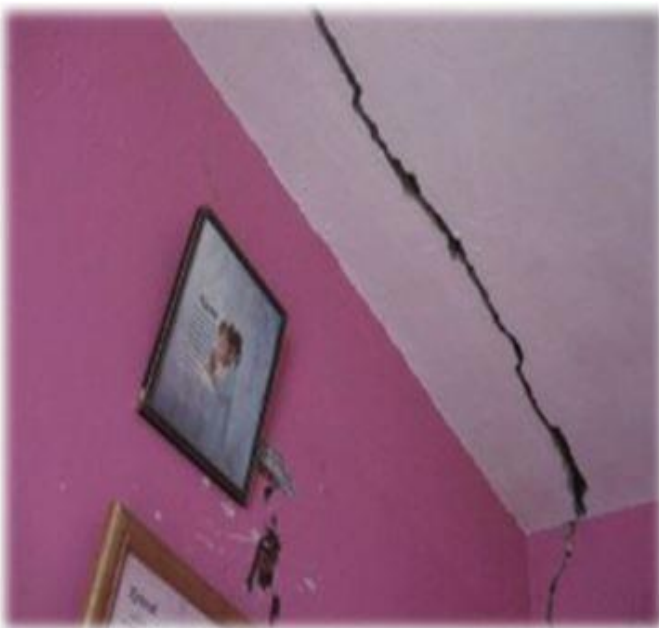
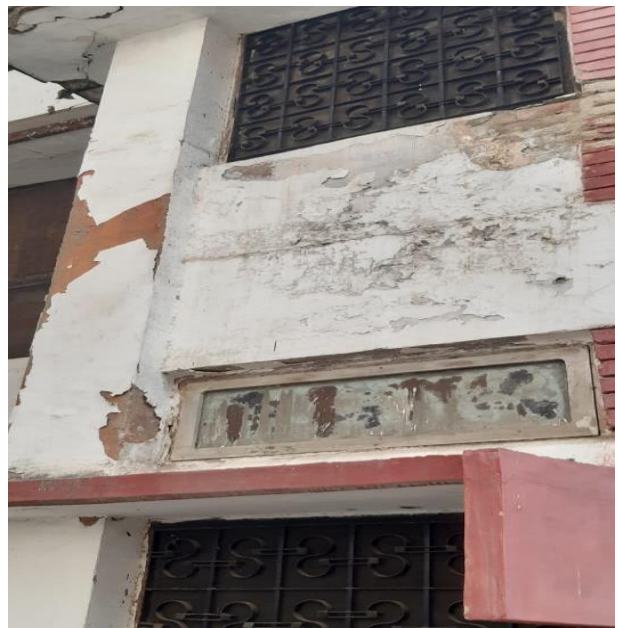
External and internal view

**External Bowing wall
bowing**

Internal cracking adjacent to

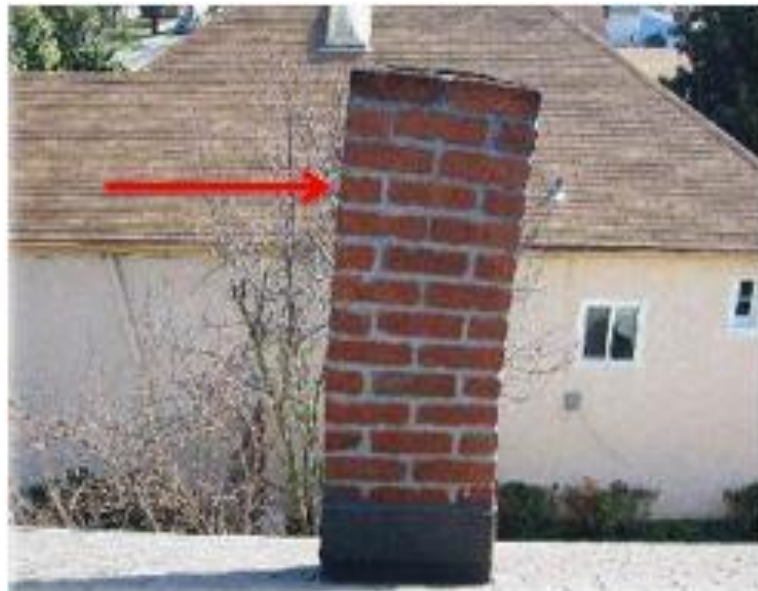
Chimney Stack

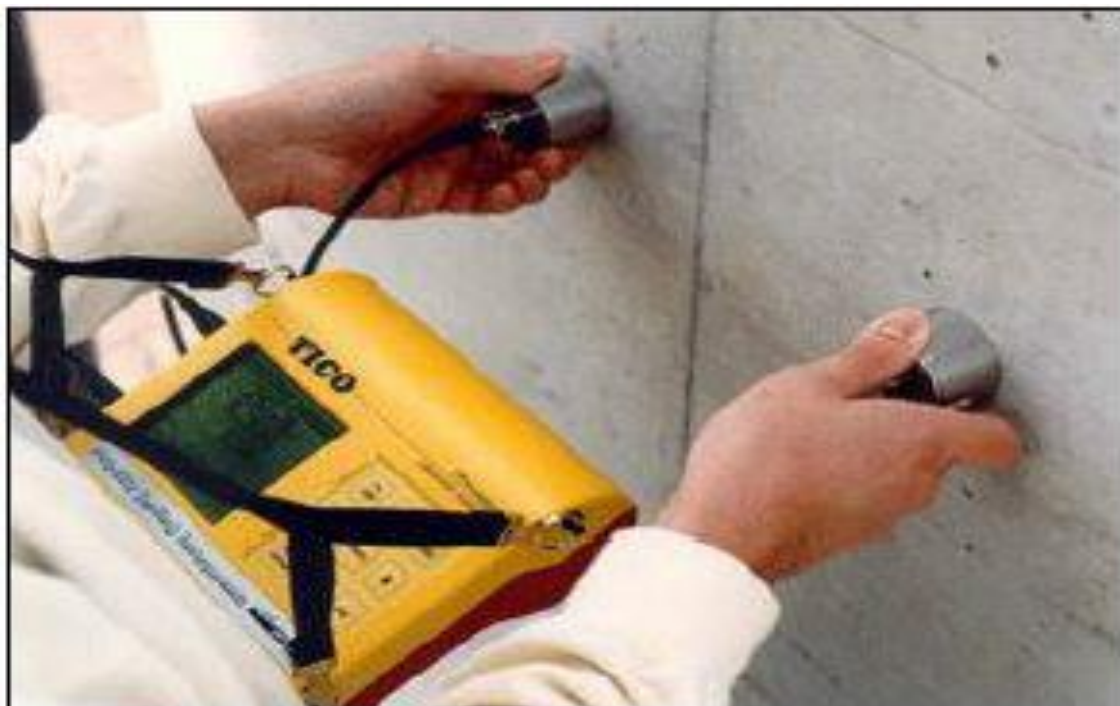
The Pulse Velocity method involves the measurement of velocity of the electronic pulses passing through concrete from a transmitter to a receiver. The principle of this test is that the velocity of sound in a solid material is a function of the square root of the ratio of its modulus of elasticity E to its density ρ . The density and elastic properties are related to the quality and strength of the material. The range of pulse velocities is from 3 to 5 km/s. These pulses in the frequency of 15-175 kHz generated and recorded by electronic circuits. The apparatus of this method consists of a transmitter and a receiver which are held against two faces of concrete. The apparatus generates pulses of ultrasonic frequency which are transmitted through concrete by the transmitter. On the other face, the receiver receives the pulses and the apparatus records them. The time of travel between initial onset and the reception of the pulse measures electronically. The average velocity of wave propagation can be measured by dividing path between the transducer and receiver by the time of travel. The velocity of pulses and the strength of concrete are correlated. Lower the velocity of pulses, lower is the strength of concrete and vice versa. This method is used in detection of the development of cracks in structures such as dams. It can be also used to check deterioration due to frost or chemical reaction.

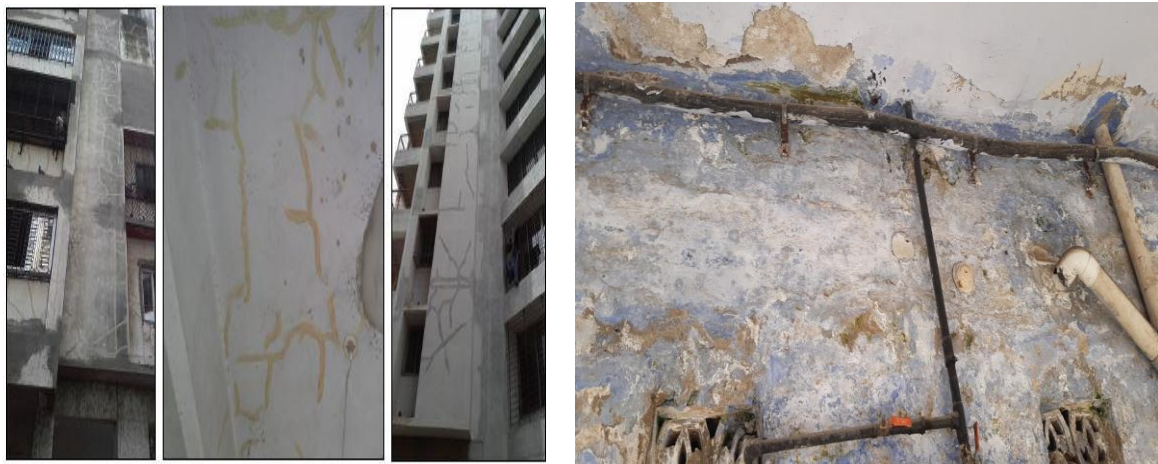
We used Portland cement grouting method to repair cracks in our selected site. Injection of slurry or a liquid solution into a soil or rock formation is termed as grouting. The injected material is referred to as the grout. The Ordinary Portland Cement used in grouting should be as per IS: 269 and sand and water should be as per IRS Concrete Bridge Code. With the approval of the Divisional Engineer, admixtures can be added to impart non-shrinkable properties and to improve flow ability of grout. The water-cement ratio (by weight) for the grout should be 0.4 to 0.5, when crack width exceeds 0.5mm, the lower ratio should be used. Pressure grouting equipment is used to inject grout in the cracks. We used Air Compressor with a capacity of 3 to 4 cum/per minute. The grouting pressure should be 2 to 4 kg/cm². After grouting, curing should be done for 14 days. Once the grouting work is done all the grouting equipment including the slurry and mixing drums, nozzles, pipes etc. should be thoroughly washed to prevent damage of the equipment. After the work has been completed, it should be inspected thoroughly by the Engineer In charge and should be kept under observation for a period of 6 months or more for its behavior after grouting. Although it is time consuming method yet it is more used because it gives better result. The result of grouting method restores and increases the strength of cracked component.

Fig. : Repair of cracks by Grouting method

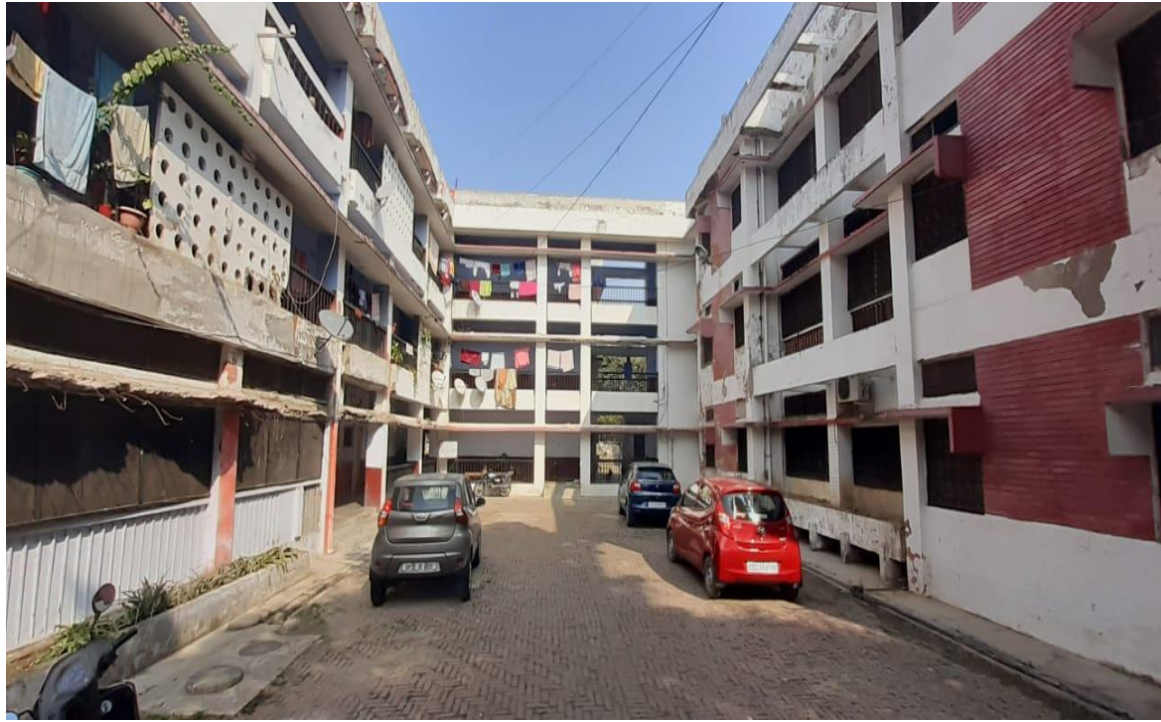
Plate 1. Front view of the building

1. Brief Discussion on the Building Understudy Emmanuel Egboga building has 53 rooms, and four floors, which are basement floor (named as FB), ground floor (named as F0), first floor (named as F1), and second floor (named as F2) as shown in Plate 1. The structural frame members consist of 129 beams, 92 columns, and 240 walls in total. It is covered at the roof with aluminum roofing sheets, and contains roof gutter for proper drainage. It also contains retaining wall that links the basement floor to the ground floor. The predominant nature of cracks observed was dormant. The dirty surface of the cracks also indicated that they were dormant.

The parts of the building caused by drying shrinkage are: F0-A-R4-W4, F1-A-R4-W1, F2-A-R2- W6. The cracks were caused by shrinkage of the plastering, since it is a surface crack; the shrinkage may be due to use of high ratio of cement to sand, and inadequate curing. Shrinkage crack occurs during the first dry spell after plastering. Their measured values were shown in Tables 2 and 3, and picture in Plate 2. The proffered solution is that, this type of crack could be left unattended up to the normal time for renewal of finishing

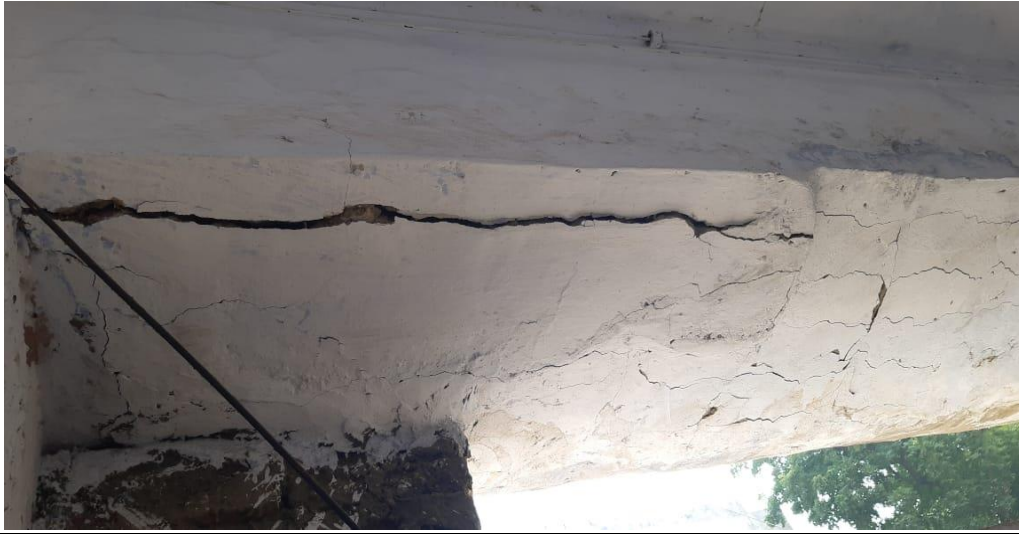
Fig: Picture of random cracks due to drying shrinkage

coat when this will get filled up, or the surface is scrap and refill with good mix ratio of cement and sand and proper curing.

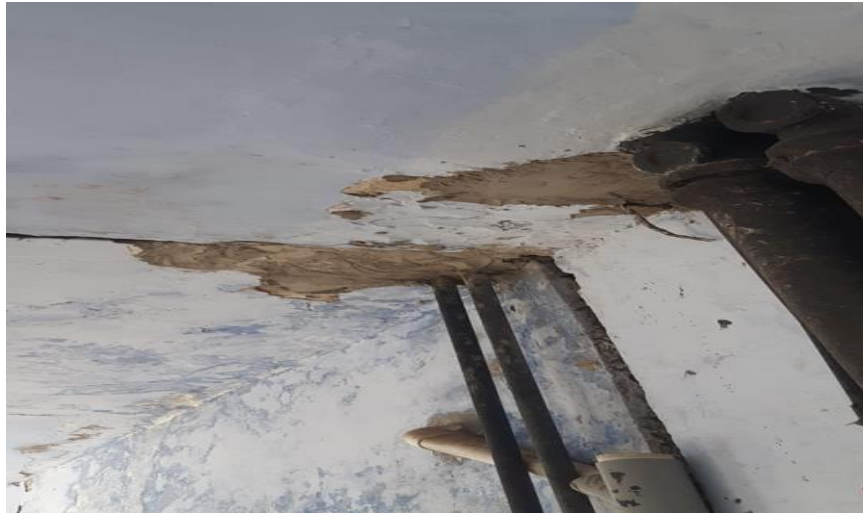
The type of crack shown in Plate 4 occurred at wallF0-A-R4-W4 (External View). This type of crack generally occurs when windows and room spans are very large. The horizontal cracks at the window lintel level (See Table 2 and Plate 4) are due to pressure exerted on the wall by slab, because of drying shrinkage and thermal contraction. This pressure resulted in bending of the wall, which caused cracking at a weak section, that is, at the lintel level of the window openings.

These cracks could have been avoided if slip joint at beam supports on the walls have been provided, to permit movement without encountering much restraint. The cracks can be repaired by filling with a mastic compound after widening and cleaning the cracks. These cracks if repaired with strong mortar have a tendency to occur again.

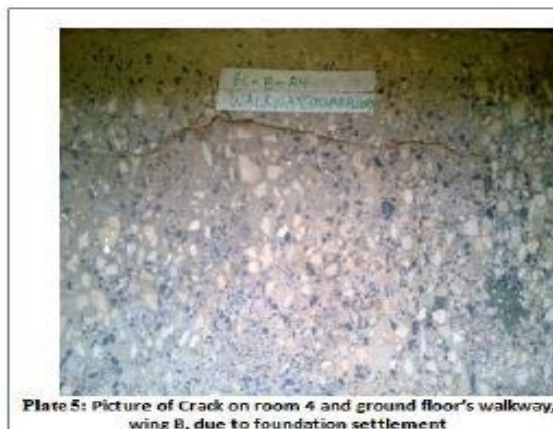
The third type of cracks observed at F0-B-R4-W1-CR1, F0-B-R4-W1-CR2, F0-B-R4-W1-CR3, F0-B-R4-W1- CR4, Door Frame, Ground floor Walkway were caused by foundation settlement

Plate 5: Picture of Crack on room 4 and ground floor's walkway, wing B, due to foundation settlement

It was discovered through topographical survey, that lack of drainage at the open courtyard allows percolation of water into the soil and thus this crack undermines the sand under the floor and including the wall strip footing. This could be said to be responsible for the cracks in the region, for the cracks occurred due to settlement of soil at the region of the courtyard. The settlement also caused crack along the wooden frames of the door, which distorted the frame making it difficult to close and open the door. For Ground Floor Walkway, the crack was caused by poor drainage of water due to heavy runoff getting into the foundation at this region. The terrazzo floor settled under human traffic load (live load) and cracked across the corridor to the adjacent room. Such a settlement generally not being uniform in different parts resulted in cracking of the ground floor walkway. The provision of appropriate drainage and reconstruction of the wall footing and the floor in the affected area will eradicate the cracks and prevent future ones. Cracking due to shrinkage of wood can be concealed with the help of architraves and will not present much of a problem. For cracking due to slack between holdfasts, the only satisfactory remedy is to dismantle the masonry so as to remove the frame and to reaffix with seasoned frame after securely fastening the holdfasts to the frame.

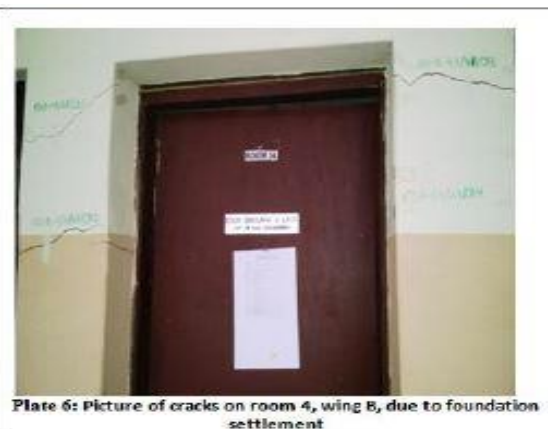
Plate 6: Picture of cracks on room 4, wing B, due to foundation settlement

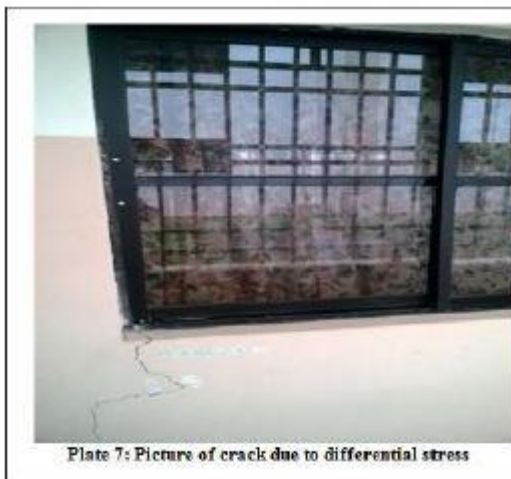
Plate 7: Picture of crack due to differential stress

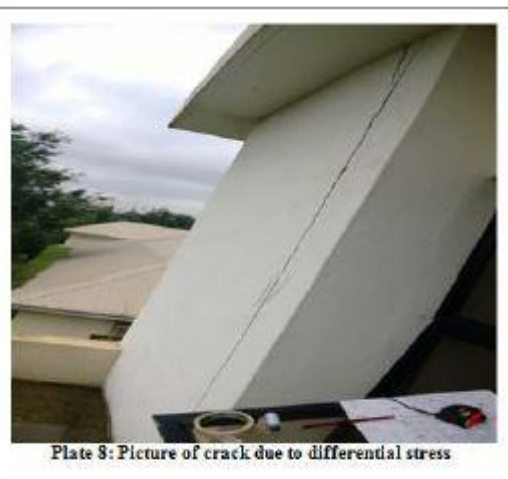
Plate 8: Picture of crack due to differential stress
