COMPARATIVE ANALYSIS OF DEFECT OCCURRING IN BITUMINOUS PAVEMENT

BACHELOR OF TECHNOLOGY

Civil Engineering

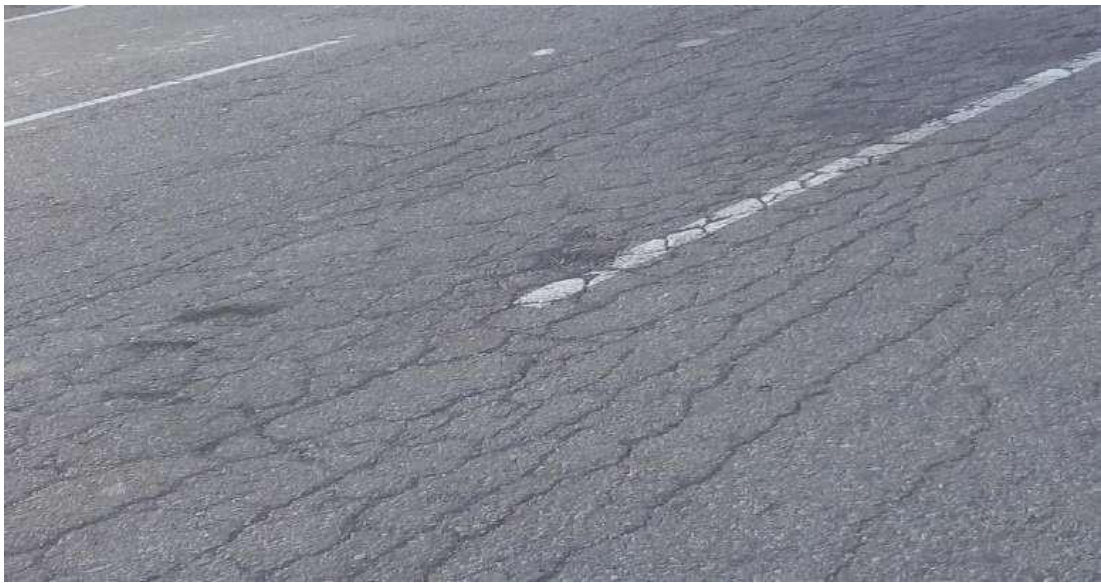
Figure 3.1 Alligator Cracks

A series of interconnected cracks caused by fatigue failure of the HMA surface under repeated traffic loading. As the number and magnitude of loads becomes too great, longitudinal cracks begin to form (usually in the wheelpaths). After repeated loading, these longitudinal cracks connect forming many-sided sharp-angled pieces that develop into a pattern resembling the back of an alligator or crocodile.

Problem: Roughness, indicator of structural failure, cracks allow moisture infiltration into the base and subgrade, eventually results in potholes and pavement disintegration if not treated.

Possible Causes: Inadequate structural support for the given loading, which can be caused by a myriad of things. A few of the more common ones are:

Repair: A fatigue cracked pavement should be investigated to determine the root cause of failure. Any investigation should involve digging a pit or coring the pavement to determine the pavement's structural makeup as well as determining whether or not subsurface moisture is a contributing factor. Once the characteristic alligator pattern is apparent, repair by crack sealing is generally ineffective. Fatigue crack repair generally falls into one of two categories:

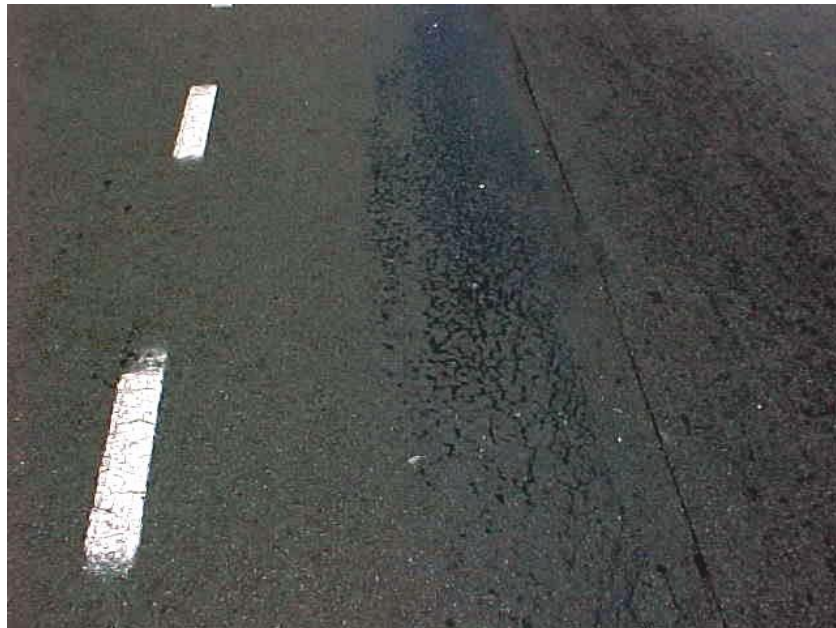
Figure 3.2 Bleeding

Possible Causes: Bleeding occurs when asphalt binder fills the aggregate voids during hot weather or traffic compaction, and then expands onto the pavement surface. Since bleeding is not reversible during cold weather or periods of low loading, asphalt binder will accumulate on the pavement surface over time. Likely causes are:

Repair: The following repair measures may eliminate or reduce the asphalt binder film on the pavement's surface but may not correct the underlying problem that caused the bleeding:

- Minor bleeding can often be corrected by applying coarse sand to blot up the excess asphalt binder.
- Major bleeding can be corrected by cutting off excess asphalt with a motor grader or removing it with a heater planer. If the resulting surface is excessively rough, resurfacing may be necessary

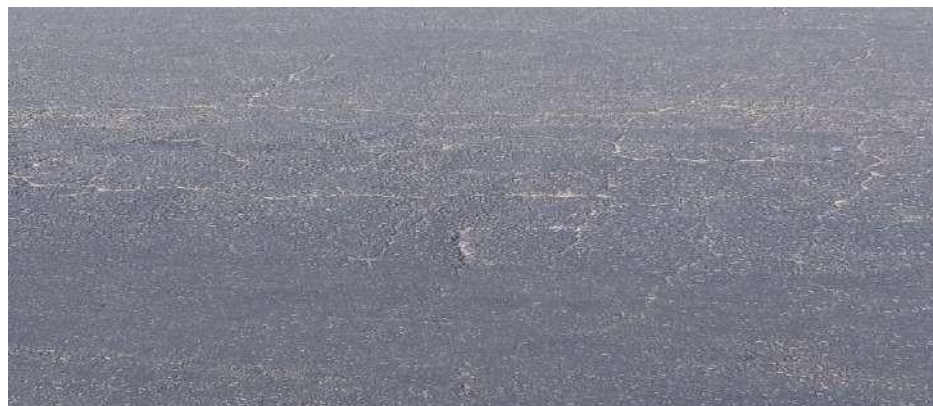
Figure 3.3 Block Cracking

Description: Interconnected cracks that divide the pavement up into rectangular pieces. Blocks range in size from approximately 1 ft² to 100 ft². Larger blocks are

generally classified as longitudinal and transverse cracking. Block cracking normally occurs over a large portion of pavement area but sometimes will occur only in non-traffic areas.

Possible Causes: HMA shrinkage and daily temperature cycling. Typically caused by an inability of asphalt binder to expand and contract with temperature cycles because of:

- Low severity cracks (< 1/2 inch wide). Crack seal to prevent (1) entry of moisture into the subgrade through the cracks and (2) further raveling of the crack edges. HMA can provide years of satisfactory service after developing small cracks if they are kept sealed (Roberts et. al., 1996¹¹). If looks are important, or cracking is extensive, a slurry seal can be placed over the sealed cracks.
- High severity cracks (> 1/2 inch wide and cracks with raveled edges). Remove and replace the cracked pavement layer with an overlay.

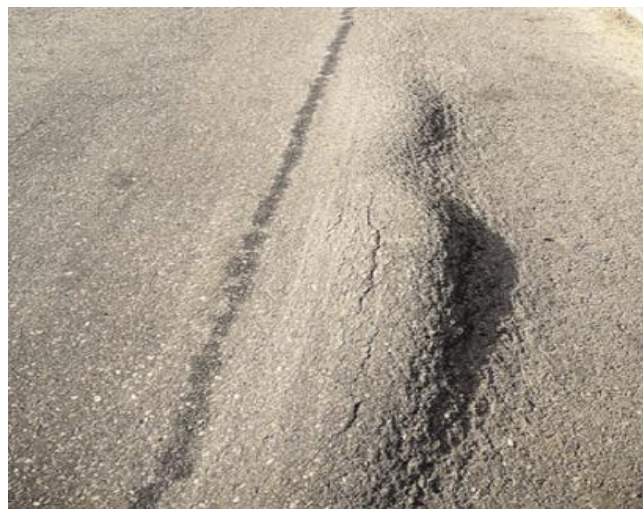
Figure 3.4 Shoving

Possible Causes: Usually caused by traffic action (starting and stopping) combined with:

- An unstable (i.e. low stiffness) HMA layer (caused by mix contamination, poor mix design, poor HMA manufacturing, or lack of aeration of liquid asphalt emulsions)

Repair: A heavily corrugated or shoved pavement should be investigated to determine the root cause of failure. Repair strategies generally fall into one of two categories:

- Small, localized areas of corrugation or shoving. Remove the distorted pavement and patch.
- Large corrugated or shoved areas indicative of general HMA failure. Remove the damaged pavement and overlay.

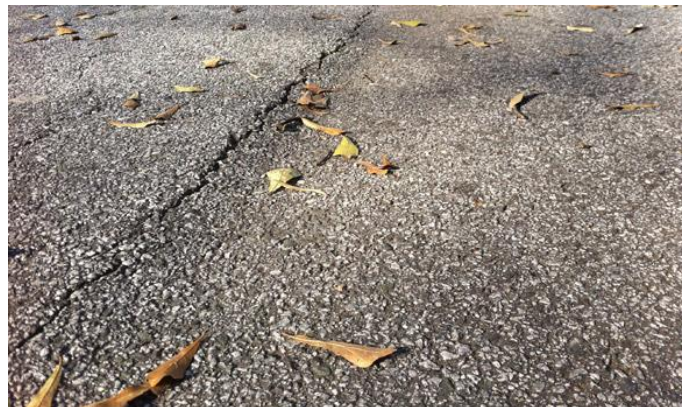
Figure 1.5 Depression

Problem: Roughness, depressions filled with substantial water can cause vehicle hydroplaning

Possible Causes: Subgrade settlement resulting from inadequate compaction during construction.

Repair: By definition, depressions are small localized areas. A pavement depression should be investigated to determine the root cause of failure. Depressions should be repaired by removing the affected pavement then digging out and replacing the area of poor subgrade. Patch over the repaired subgrade.

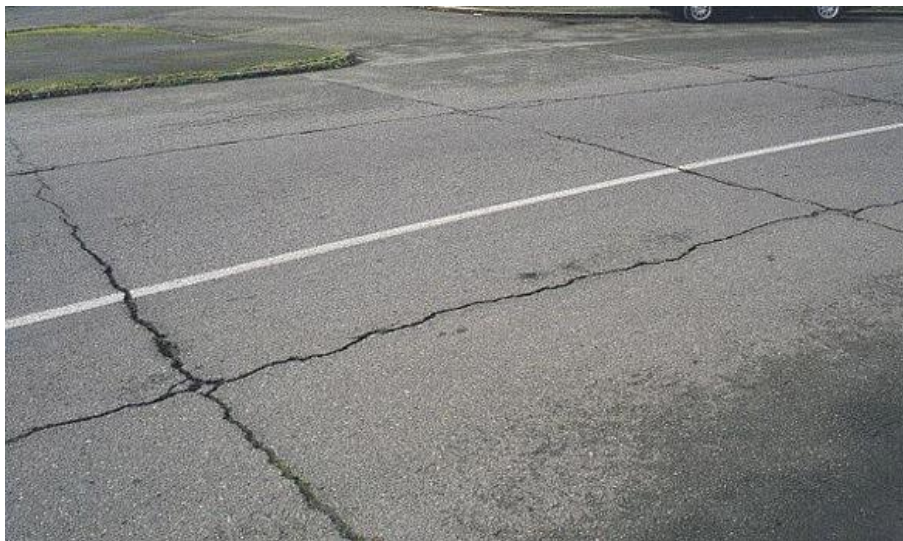
Figure 3.6 Joint Reflection Cracking

Cracks in a flexible overlay of a rigid pavement. The cracks occur directly over the underlying rigid pavement joints. Joint reflection cracking does not include reflection cracks that occur away from an underlying joint or from any other type of base (e.g., cement or lime stabilized).

Possible Causes: Movement of the rigid pavement slab beneath the HMA surface because of thermal and moisture changes. Generally not load initiated, however loading can hasten deterioration.

Repair: Strategies depend upon the severity and extent of the cracking:

- Low severity cracks (< 1/2 inch wide and infrequent cracks). Crack seal to prevent (1) entry of moisture into the subgrade through the cracks and (2) further raveling of the crack edges. In general, rigid pavement joints will eventually reflect through an HMA overlay without proper surface preparation.
- High severity cracks (> 1/2 inch wide and numerous cracks). Remove and replace the cracked pavement layer with an overlay after proper preparation of the underlying rigid pavement.

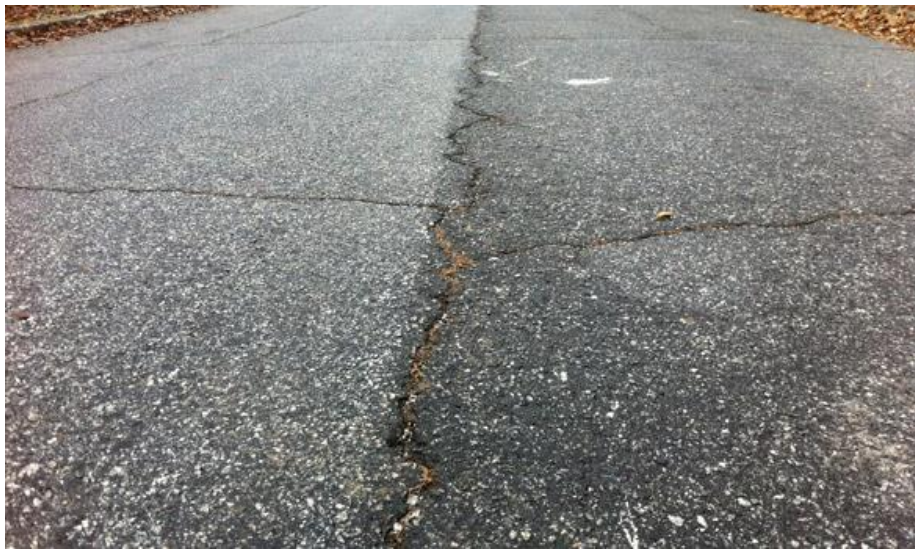
Figure 3.7 Longitudinal cracking

Cracks parallel to the pavement's centerline or laydown direction. Usually a type of fatigue cracking.

Problem: Allows moisture infiltration, roughness, indicates possible onset of fatigue cracking and structural failure.

- Poor joint construction or location. Joints are generally the least dense areas of a pavement. Therefore, they should be constructed outside of the wheelpath so that they are only infrequently loaded. Joints in the wheelpath will general fail prematurely.

- A reflective crack from an underlying layer (not including joint reflection cracking)
- HMA fatigue (indicates the onset of future fatigue cracking)
- Top-down cracking

- Low severity cracks (< 1/2 inch wide and infrequent cracks). Crack seal to prevent (1) entry of moisture into the subgrade through the cracks and (2) further raveling of the crack edges. HMA can provide years of satisfactory service after developing small cracks if they are kept sealed (Roberts et. al., 1996^[1]).
- High severity cracks (> 1/2 inch wide and numerous cracks). Remove and replace the cracked pavement layer with an overlay.

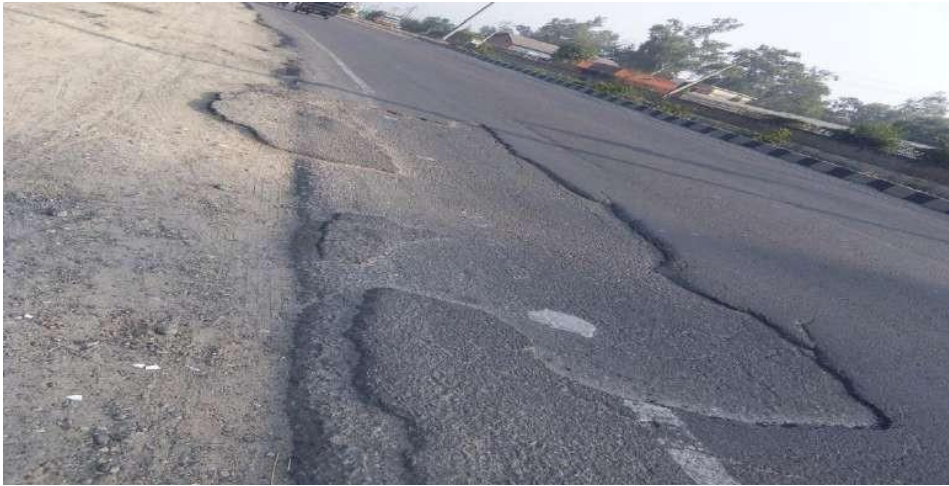
Figure 3.8 Patching

An area of pavement that has been replaced with new material to repair the existing pavement. A patch is considered a defect no matter how well it performs.

- Previous localized pavement deterioration that has been removed and patched
- Utility cuts

Repair: Patches are themselves a repair action. The only way they can be removed from a pavement's surface is by either a structural or non-structural overlay.

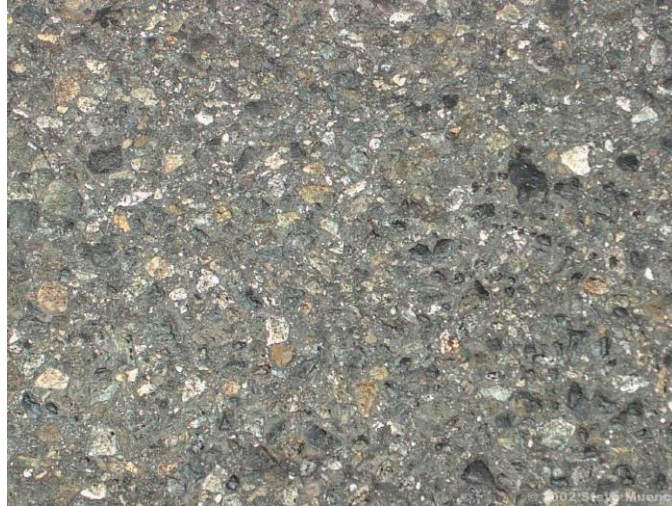
Figure 3.9 Polished aggregate

Possible Causes: Repeated traffic applications. Generally, as a pavement ages the protruding rough, angular particles become polished. This can occur quicker if the aggregate is susceptible to abrasion.

Repair: Apply a skid-resistant slurry seal, BST or non-structural overlay.

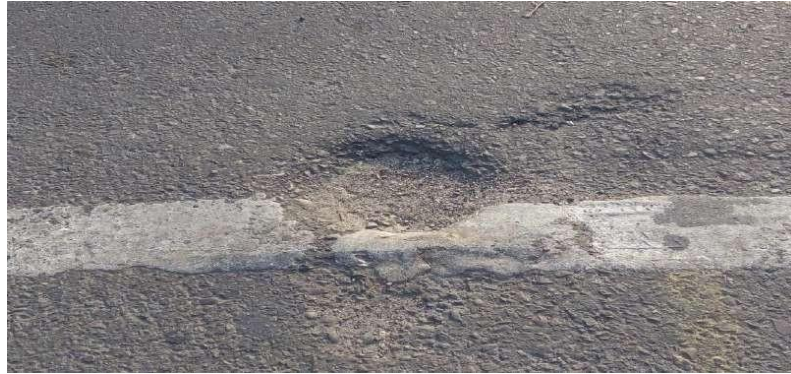
Figure 3.10 Potholes

Problem: Roughness (serious vehicular damage can result from driving across potholes at higher speeds), moisture infiltration

Possible Causes: Generally, potholes are the end result of fatigue cracking. As fatigue cracking becomes severe, the interconnected cracks create small chunks of pavement, which can be dislodged as vehicles drive over them. The remaining hole after the pavement chunk is dislodged is called a pothole.

Repair: In accordance with patching techniques.

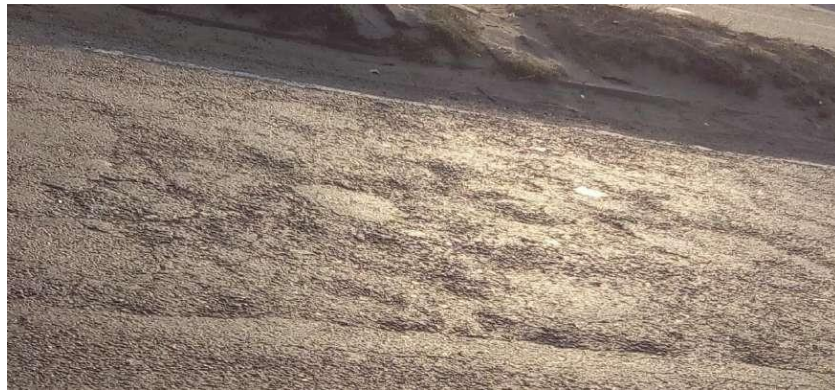
Figure 3.11 Ravelling

Problem: Loose debris on the pavement, roughness, water collecting in the raveled locations resulting in vehicle hydroplaning, loss of skid resistance

- Loss of bond between aggregate particles and the asphalt binder as a result of:
- Asphalt binder aging. Aging is generally associated with asphalt binder oxidation as it gets older. As the asphalt binder gets older, oxygen reacts with its constituent molecules resulting in a stiffer, more viscous material that is more likely to lose aggregates on the pavement surface as they are pulled away by traffic.
- A dust coating on the aggregate particles that forces the asphalt binder to bond with the dust rather than the aggregate
- Aggregate segregation. If fine particles are missing from the aggregate matrix, then the asphalt binder is only able to bind the remaining coarse particles at their relatively few contact points.
- Inadequate compaction during construction. High density is required to develop sufficient cohesion within the HMA. Often, inadequate compaction

Repair: A raveled pavement should be investigated to determine the root cause of failure. Repair strategies generally fall into one of two categories:

- Small, localized areas of raveling. Remove the raveled pavement and patch. If the pavement is still structurally sound, the raveling can be fixed with a fog seal or slurry seal.
- Large raveled areas indicative of general HMA failure. Remove the damaged pavement and overlay.

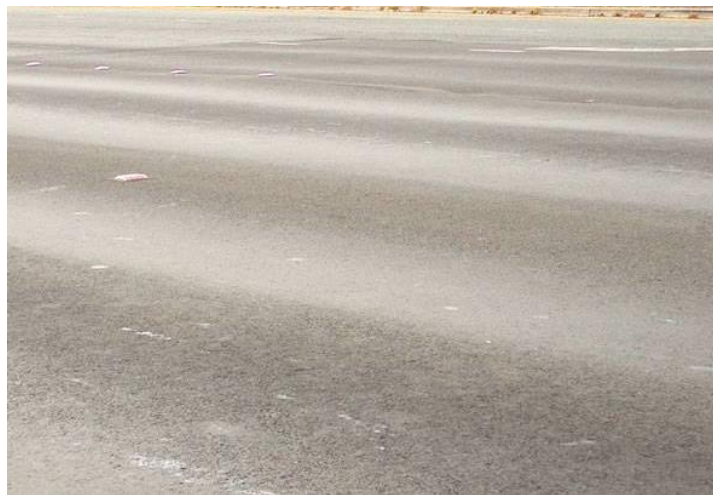
Figure 3.12 Rutting

Problem: Ruts filled with water can cause vehicle hydroplaning, can be hazardous because ruts tend to pull a vehicle towards the rut path as it is steered across the rut.

Possible Causes: Permanent deformation in any of a pavement's layers or subgrade usually caused by consolidation or lateral movement of the materials due to traffic loading. Specific causes of rutting can be:

- Insufficient compaction of HMA layers during construction. If it is not compacted enough initially, HMA pavement may continue to densify under traffic loads.
- Subgrade rutting (e.g., as a result of inadequate pavement structure)
- Improper mix design or manufacture (e.g., excessively high asphalt content, excessive mineral filler, insufficient amount of angular aggregate particles)

Repair: A heavily rutted pavement should be investigated to determine the root cause of failure (e.g. insufficient compaction, subgrade rutting, poor mix design or studded tire wear). Slight ruts (< 1/3 inch deep) can generally be left untreated. Pavement with deeper ruts should be leveled and overlaid.

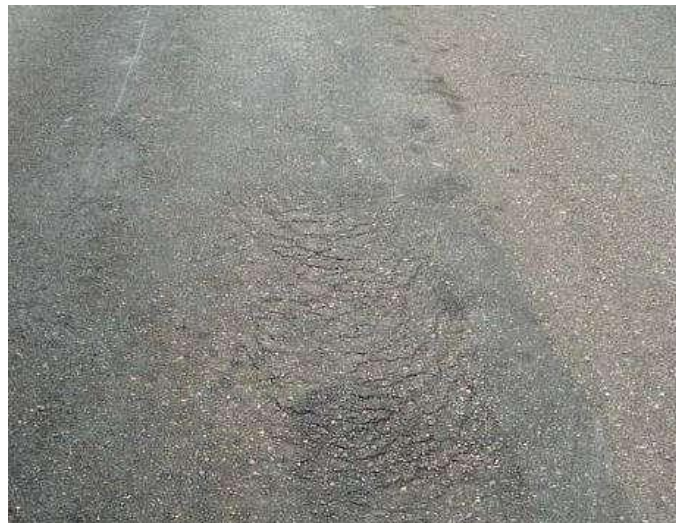
Figure 3.13 Slippage

Crescent or half-moon shaped cracks generally having two ends pointed into the direction of traffic.

Possible Causes: Braking or turning wheels cause the pavement surface to slide and deform. The resulting sliding and deformation is caused by a low-strength surface mix or poor bonding between the surface HMA layer and the next underlying layer in the pavement structure.

Repair: Removal and replacement of affected area.
